REPORT ON THE REHABILITATION, OPERATION AND  
TREATMENT PERFORMANCE OF MPIRA/BALAKA  
MAIN WATER TREATMENT WORKS

THE DEPARTMENT OF WATER  
MINISTRY OF WORKS, REPUBLIC OF MALAWI.

February 1992

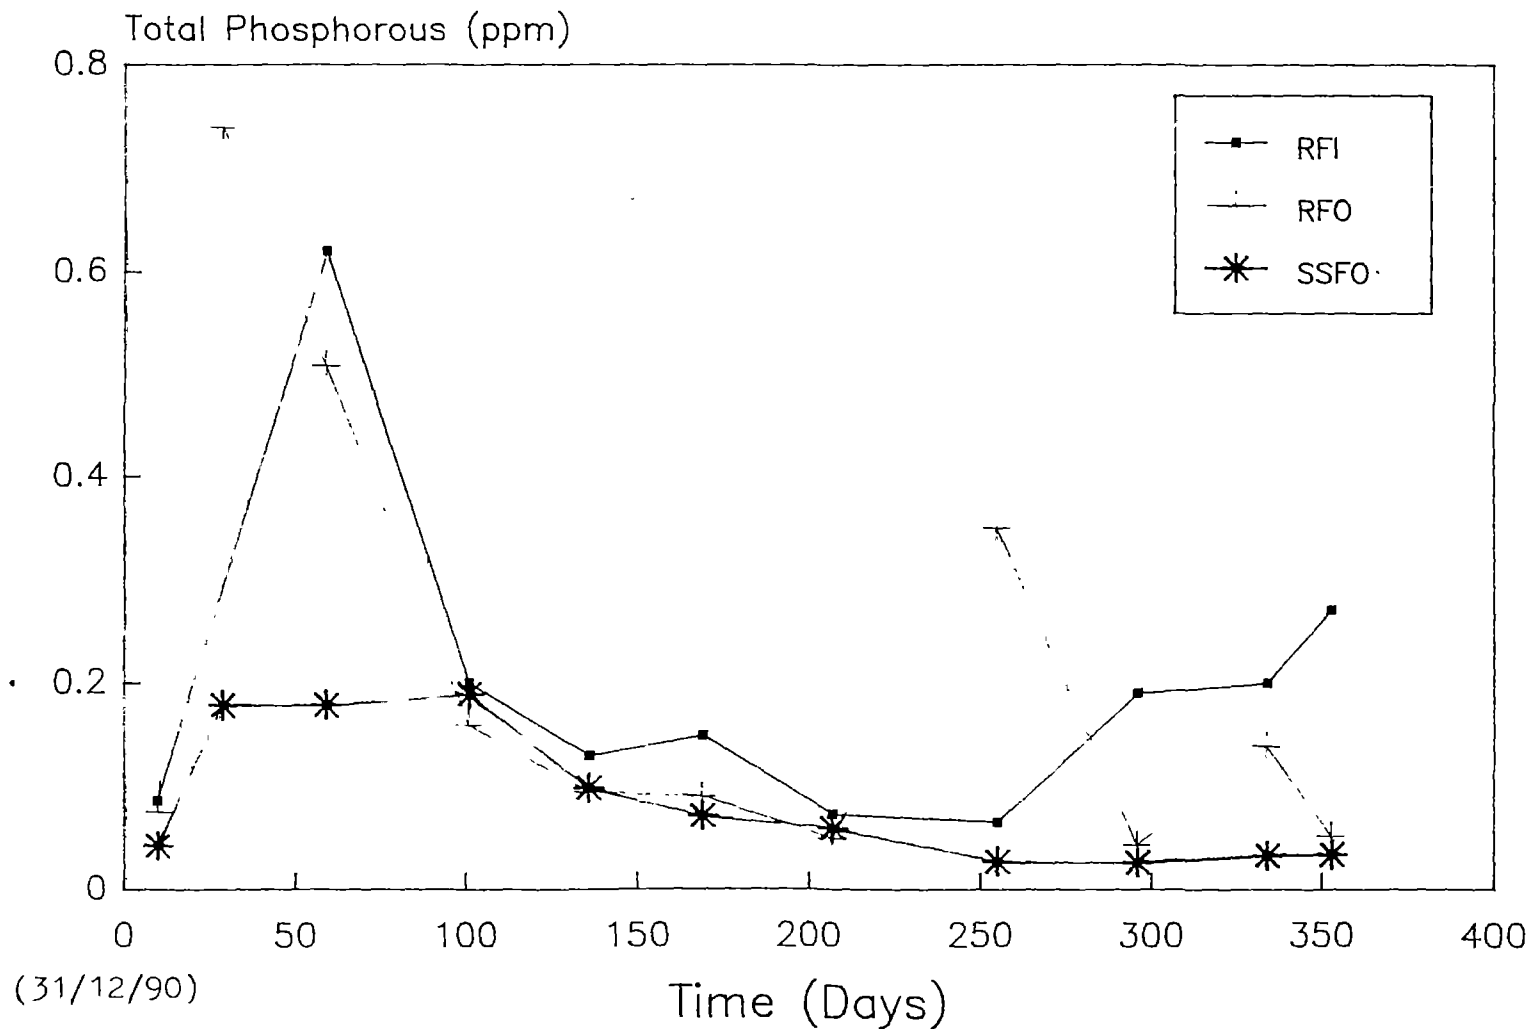
MAIN TREATMENT PLANT TOTAL PHOSPHOROUS CHANGES

The graphs on Appendix.11 clearly show that in the reservoir, there was a very clear tendency of the total phosphorus increasing with depth. However, in the treatment plant, one can observe the existence of a moderate capacity to remove the total Phosphorus. While the maximum RFI total Phosphorus was 0.62 ppm, the SSFO value ranged from 0.027 to 0.19 ppm. In general, the total phosphorus levels in the RFI was fairly similar to the same for the 20m depth in the reservoir.

The rainy season led to some increase in total Phosphorus concentration thus reinforcing the validity of the theory of leaching from nearby farmlands. The shifting of most of the farmers from the Mpirã river catchment which was largely completed in August 1991 is expected to reduce even further the effect of nutrients like Phosphorus and Nitrogen on algae growth in the reservoir in
