Scaling School Water, Sanitation, and Hygiene in Rural Kenya:

An Assessment of the Kenya Education Sector Support Program

SWASH+: Sustaining and Scaling School Water, Sanitation, and Hygiene Plus Community Impact

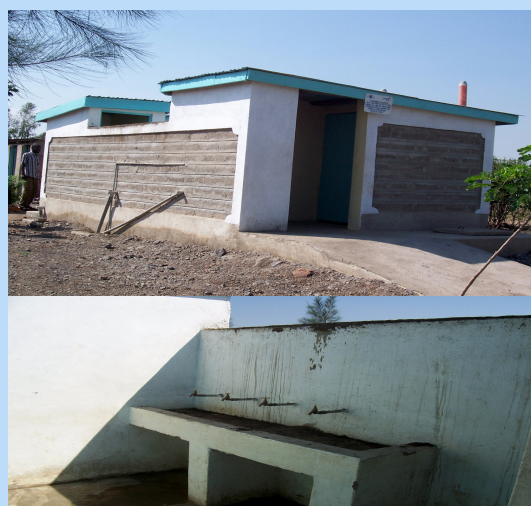
Figure 1. Exterior and taps of KESSP-design latrine/washroom facility at Kamunda Primary, constructed by Water.org.

Most of the schools did not construct latrines that allowed for ventilation improvement (VIP latrines) recommended in the design. Only one of the former KESSP design schools constructed a hand washing facility within the KESSP design latrine/washroom building. Only two schools included a washroom in their design; others indicated that there was no need and had to modify the design to allow for an additional pit latrine. Furthermore, most of the schools did not include a provision for manholes for exhausting the latrines. In schools that had installed hand-washing stations, most of the sink taps were well beyond the reach of small children.

In schools in which the KESSP latrine design was constructed by Water.org, the total cost of constructing the facility was approximately Ksh 515,000, which is well above the Ksh 300,000 cost estimate given by KESSP⁶.

- **Latrine/washroom design:** No schools receiving funds for WASH through KESSP implemented the recommended latrine/washroom design, citing high cost and lack of expertise or example in how to construct it. A more modest, lower cost design should be considered for future iterations of KESSP. In the Water.org schools having the KESSP design latrines/washrooms, the design was generally acceptable by school staff and students. To enhance acceptability and utility of the washrooms by girls, there is need to improve the design to allow for some illumination in the washrooms (no need to make them dark). There is also need to provide school-wide education with the view to removing the taboo from the concept of menstruation to remove normative barriers to utilization of washrooms. Provision of water in the facilities should be prioritized, and the hand washing stations should be low enough to be accessed by younger pupils.

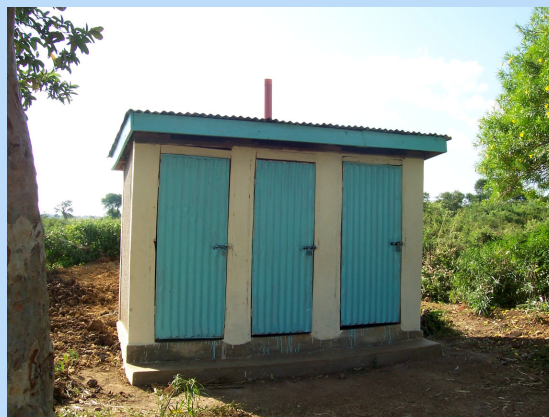
Overall design implementation: Generally, schools that had previously received KESSP funds to construct latrines expressed that the design was expensive and could not be implemented accurately using the allocated funds per unit latrine. On the actual design that was implemented by these schools, it was evidenced that the KESSP design was not followed in constructing the sanitation facilities. For example, in some KESSP-funded schools there was no provision for adapted latrines for students with physical

Figure 2. Latrines constructed with KESSP funds at DierAora Primary did not use the recommended KESSP design.

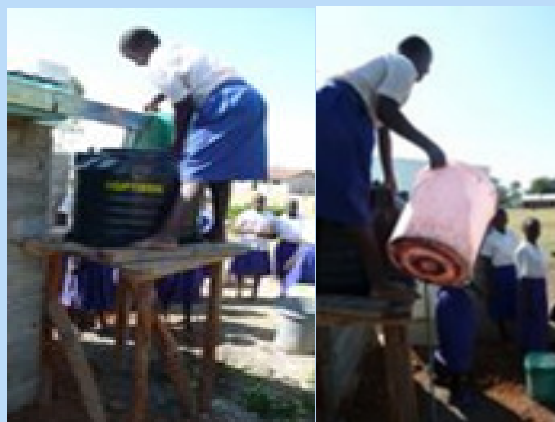
Safety: In schools that installed hand-washing tanks within the latrine facilities, some students expressed that they were scared of filling water tanks. The tanks were observed to be on a platform approximately 1.5 meters above the ground, and the platform lacks a ladder or stairs to climb to assist in filling water (see Figure 3). Tanks that use rain collection system were observed to lack screens such that dead insects were seen in some of the tanks⁷.

Figure 3. Girls at Kamunda School trying to access and pour water into the water tank.

⁷ Ideally, the tanks have filters/screens at the pipes connecting the roof with the gutters, to trap any debris from rainwater channeled from the roof. However, given the prolonged dry season, the pupils are fetching water from the earthpans and other sources and emptying into the tank, so the insects could either be from turbid water or get in when the lid is open and water being emptied. Ideally the lid should remain closed until during cleaning. While a filter can be put on the mouth, it will make cleaning and refilling of the tank difficult.
